# **Third-Party Environmental Compliance Audit, WORM Pipeline – Reinstatement audit**

**Rev 0**

**8 September 2025**

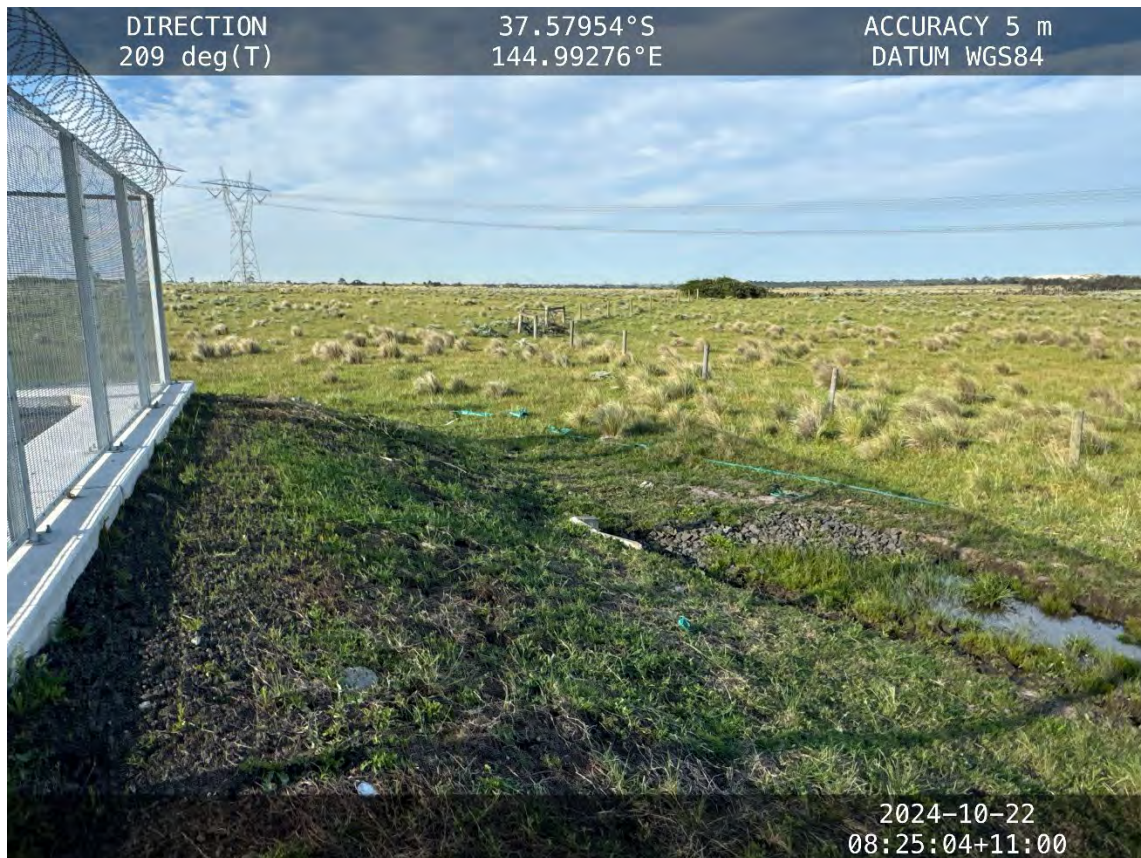
KP50 Wollert Compressor Station - base of batters around new compressor area with damaged and strewn sediment fencing.

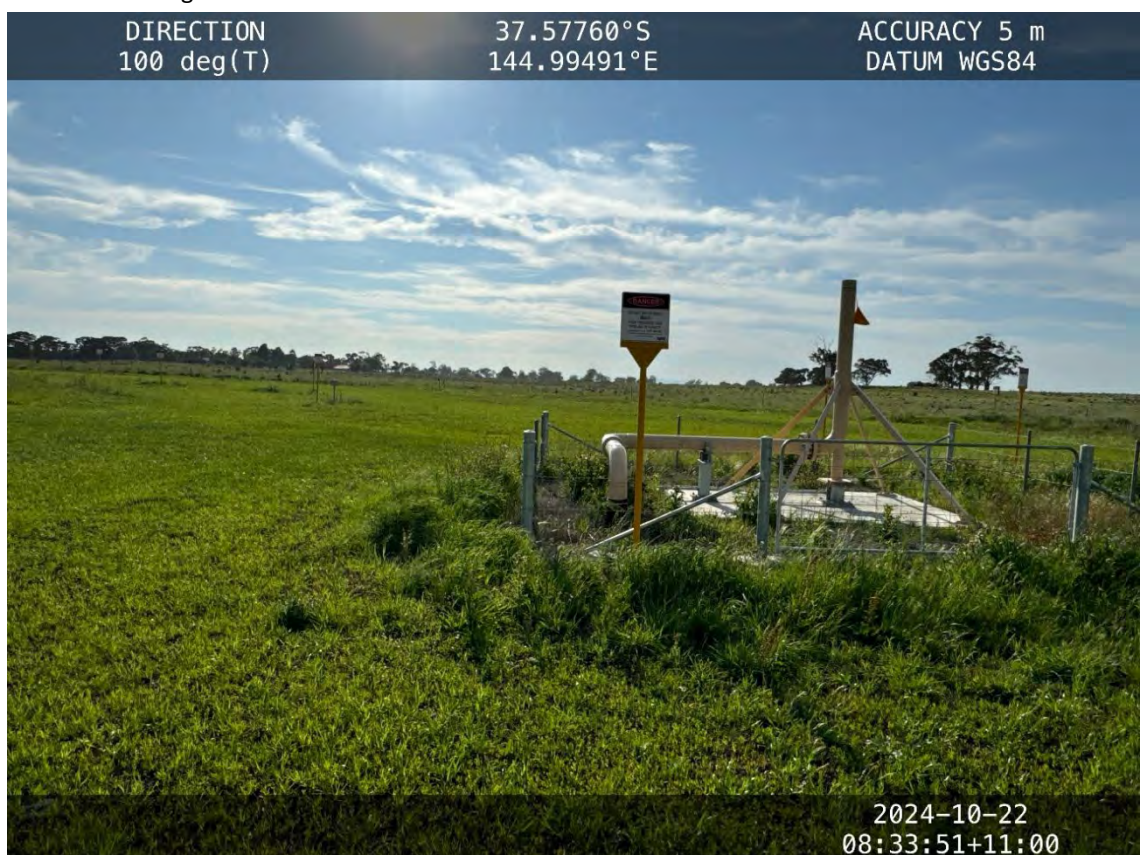
KP50 Wollert Compressor Station – vegetation coverage surrounding pipeline facility.

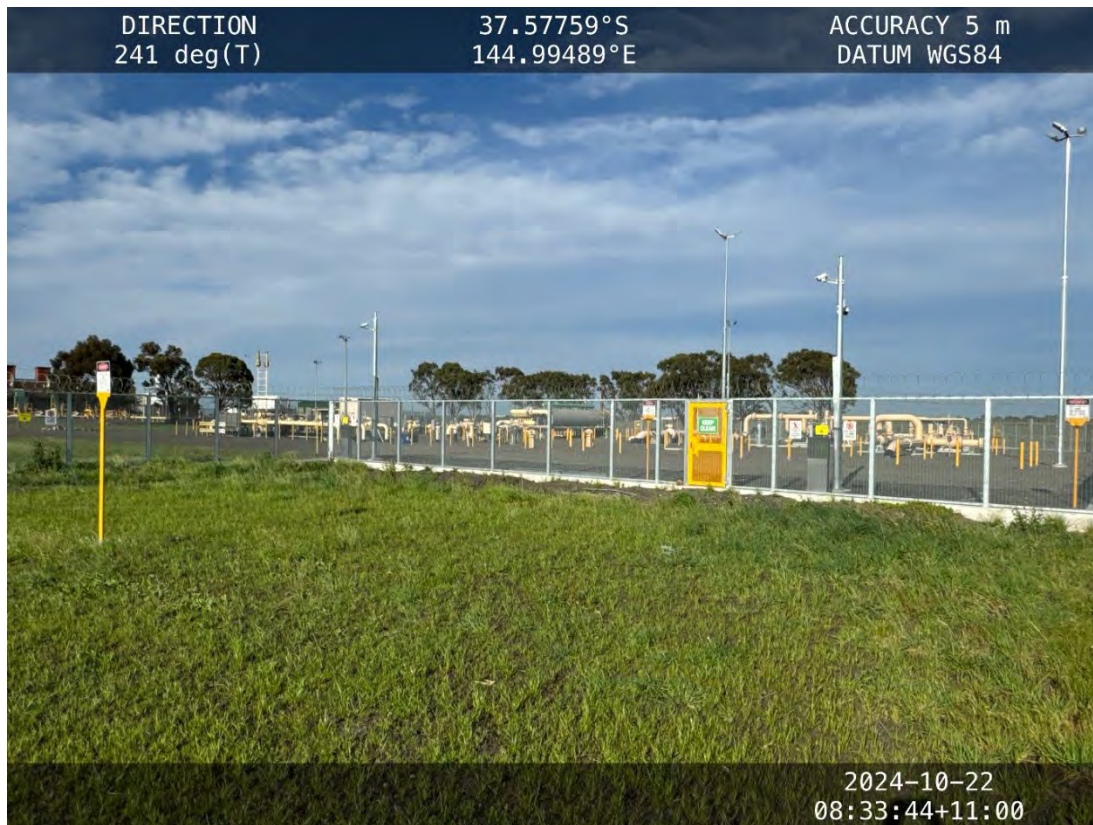
KP50 Wollert Compressor Station – rehabilitation surrounding the perimeter of the compressor station with pipeline marker.

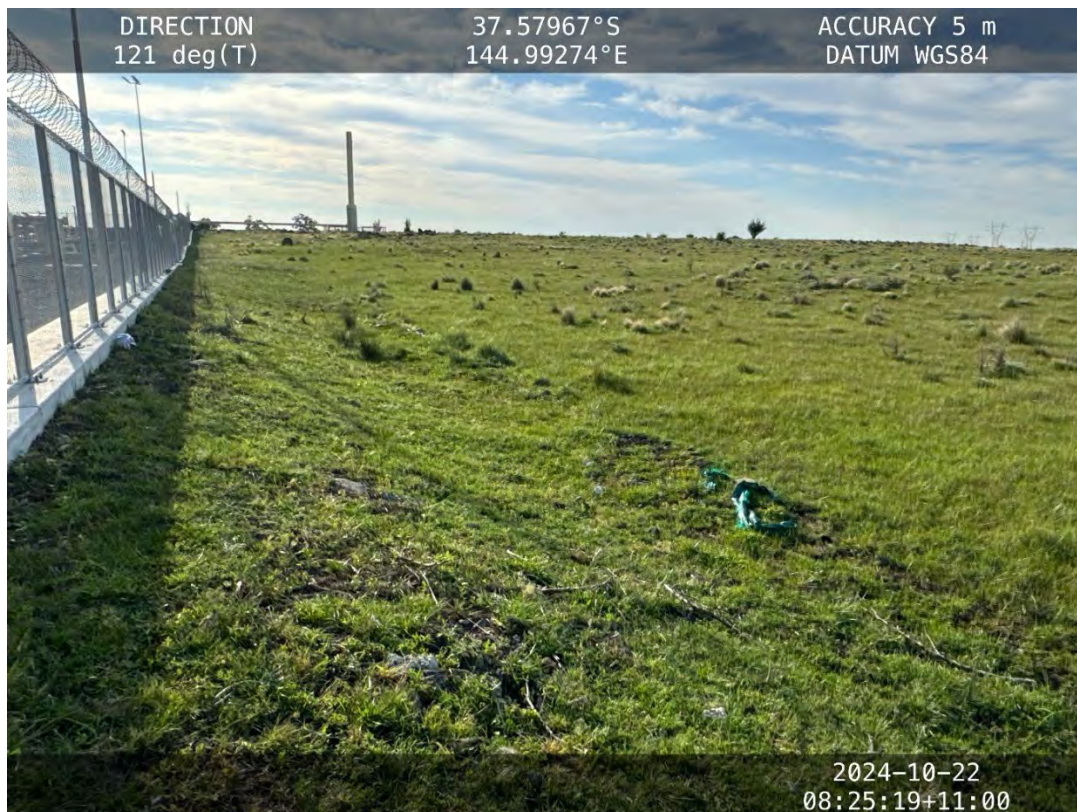
KP50 Wollert Compressor Station – stable and flat land surrounding the batters with remains of sediment fencing.

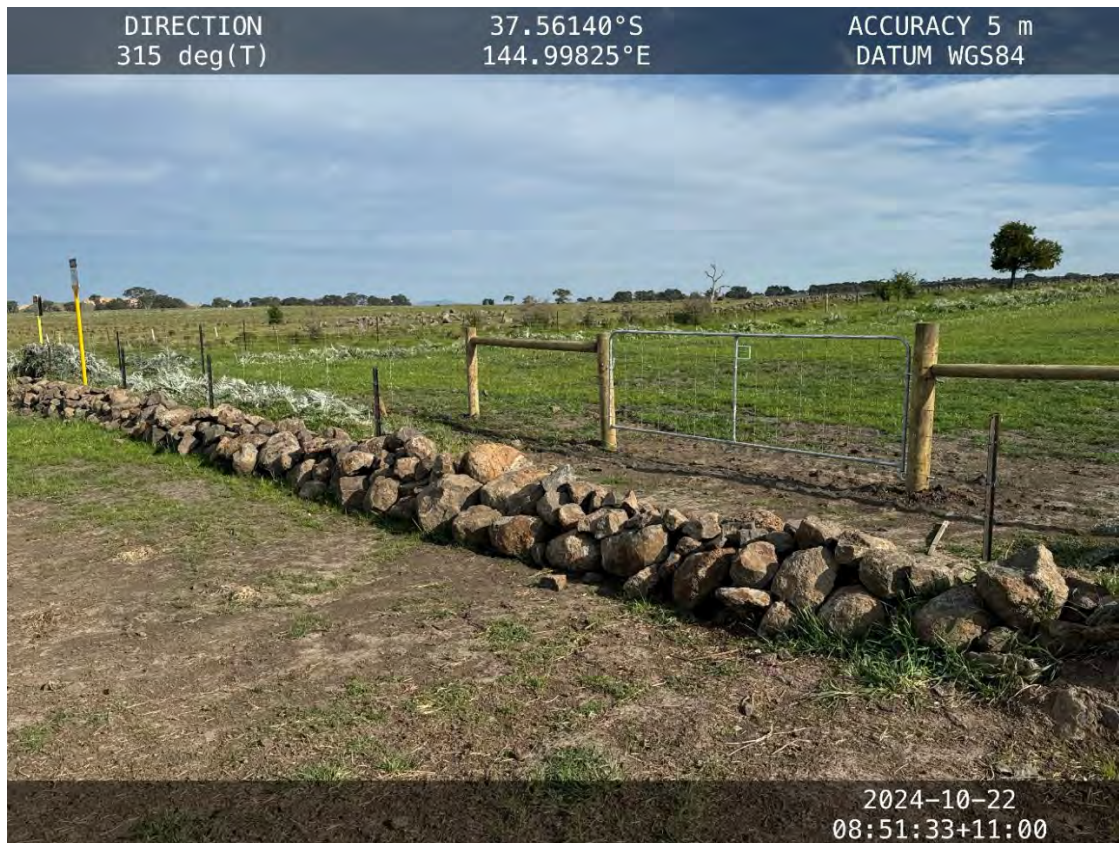
KP48.6 Conservation area 28b – reinstated rock wall across the rehabilitated pipeline right of way, stable ground with minimal vegetation growth.

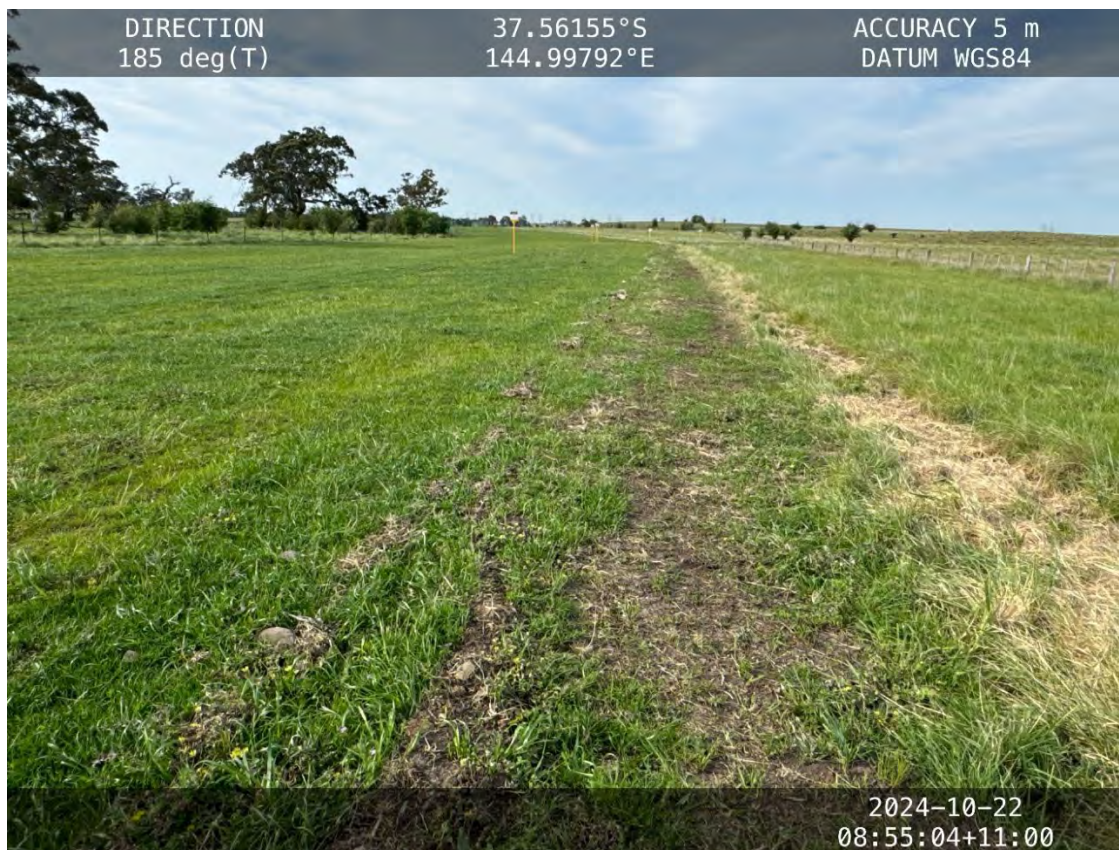
KP48.6 Conservation area 28b – rock placement and evident edge of pipeline rehabilitation area.

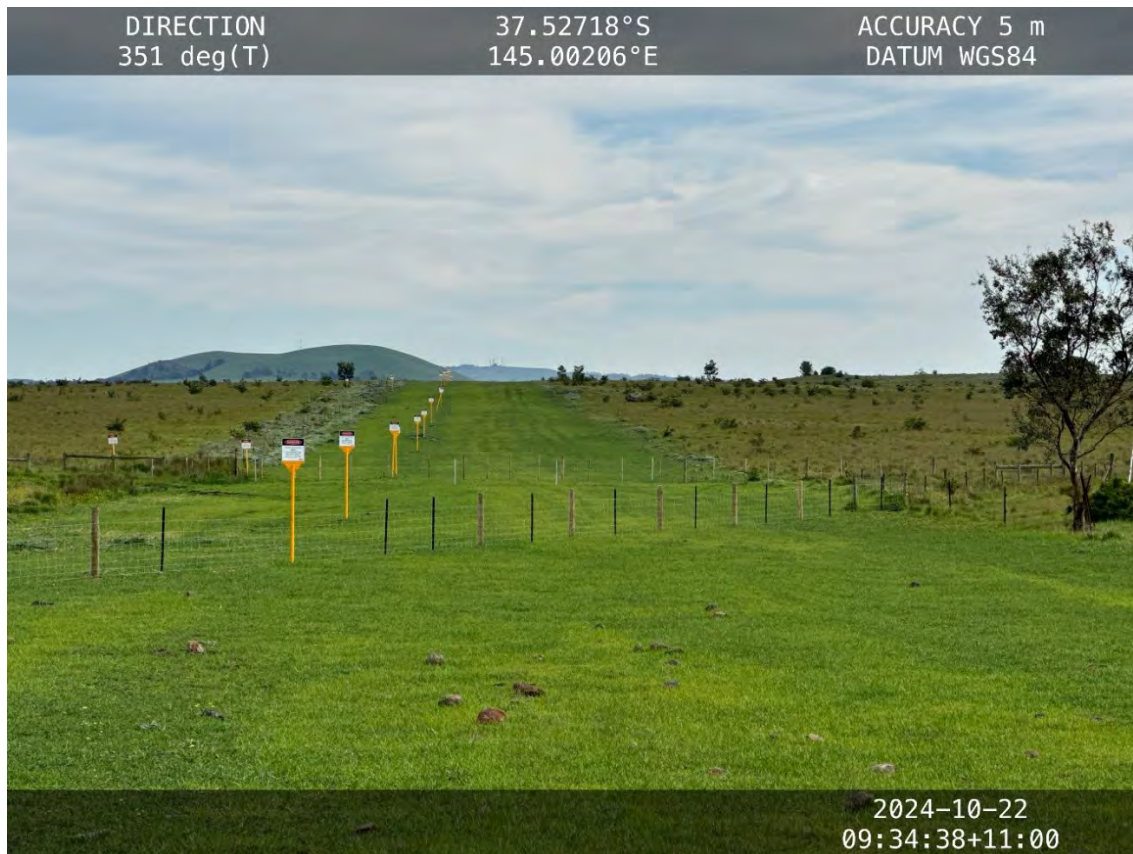
North of Donnybrook Road (adjacent to new residential area) – rehabilitated RoW with fencing and pipeline markers installed.

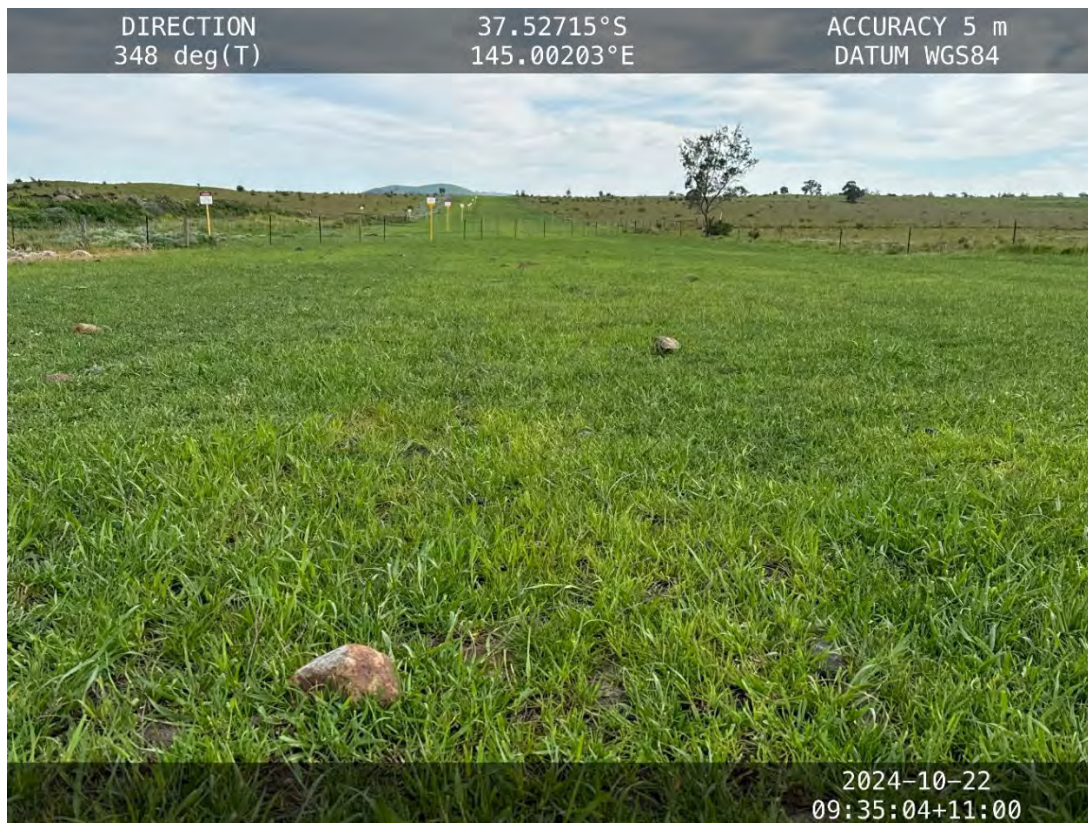
North of Donnybrook Road (adjacent to new residential area) – rehabilitated vegetation with rock placement.

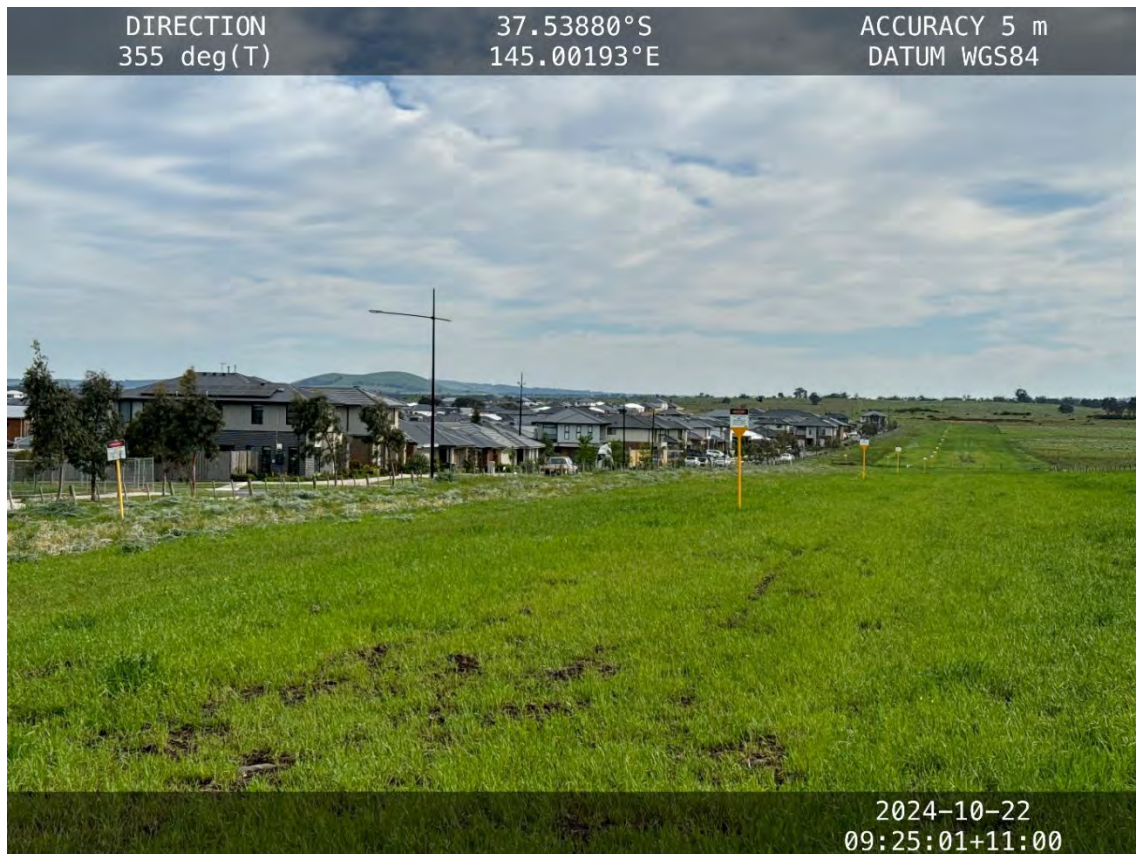
North of Donnybrook Road (adjacent to new residential area) – rehabilitation adjacent to housing.

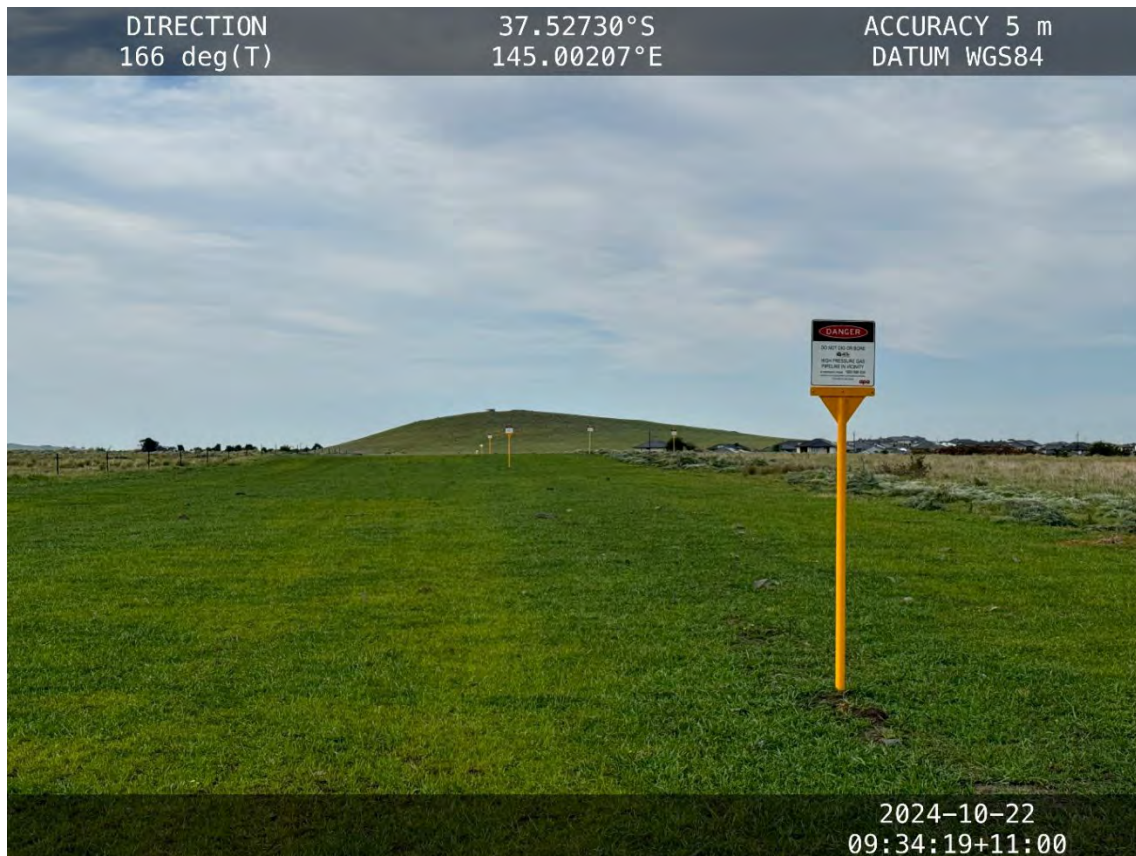
North of Donnybrook Road (adjacent to new residential area) – rehabilitated vegetation with pipeline markers evident. Evident vegetation species change along border of pipeline right-of-way.

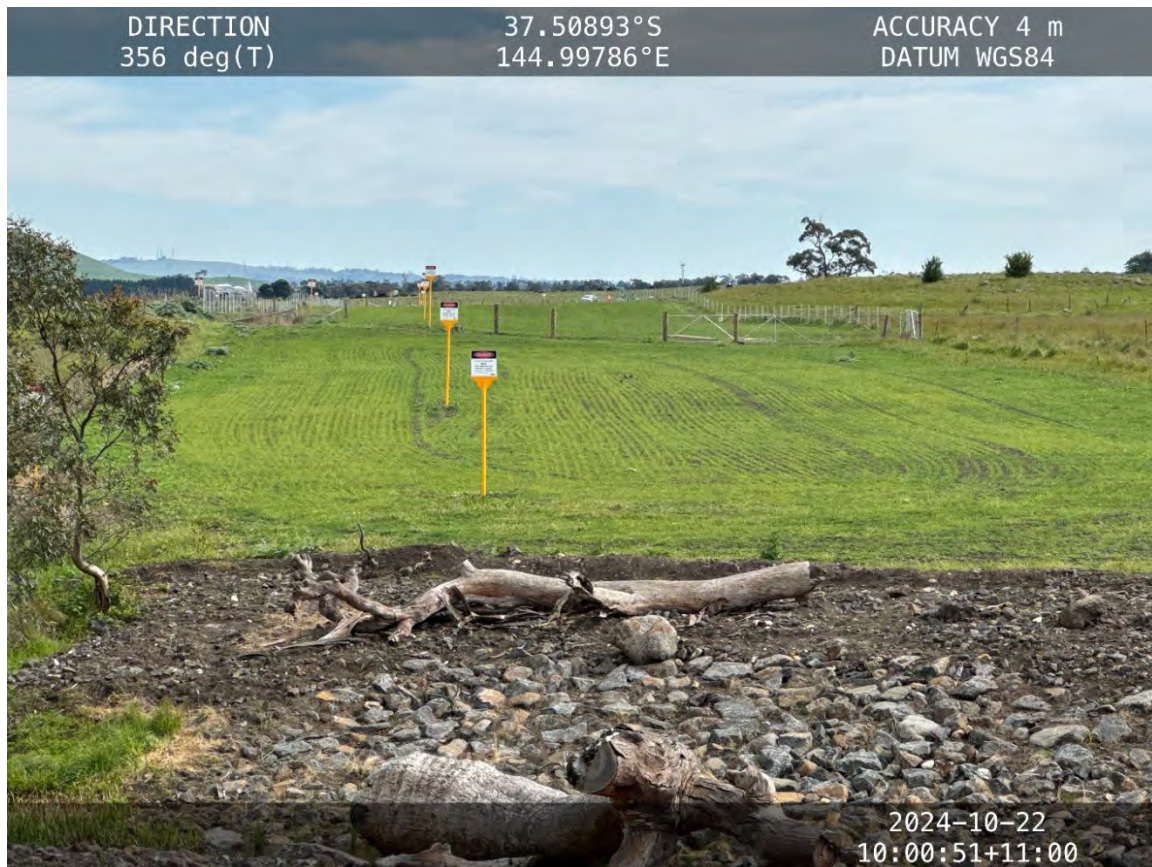
KP 42 Merri Creek – north bank with vegetation growth and pipeline markers.

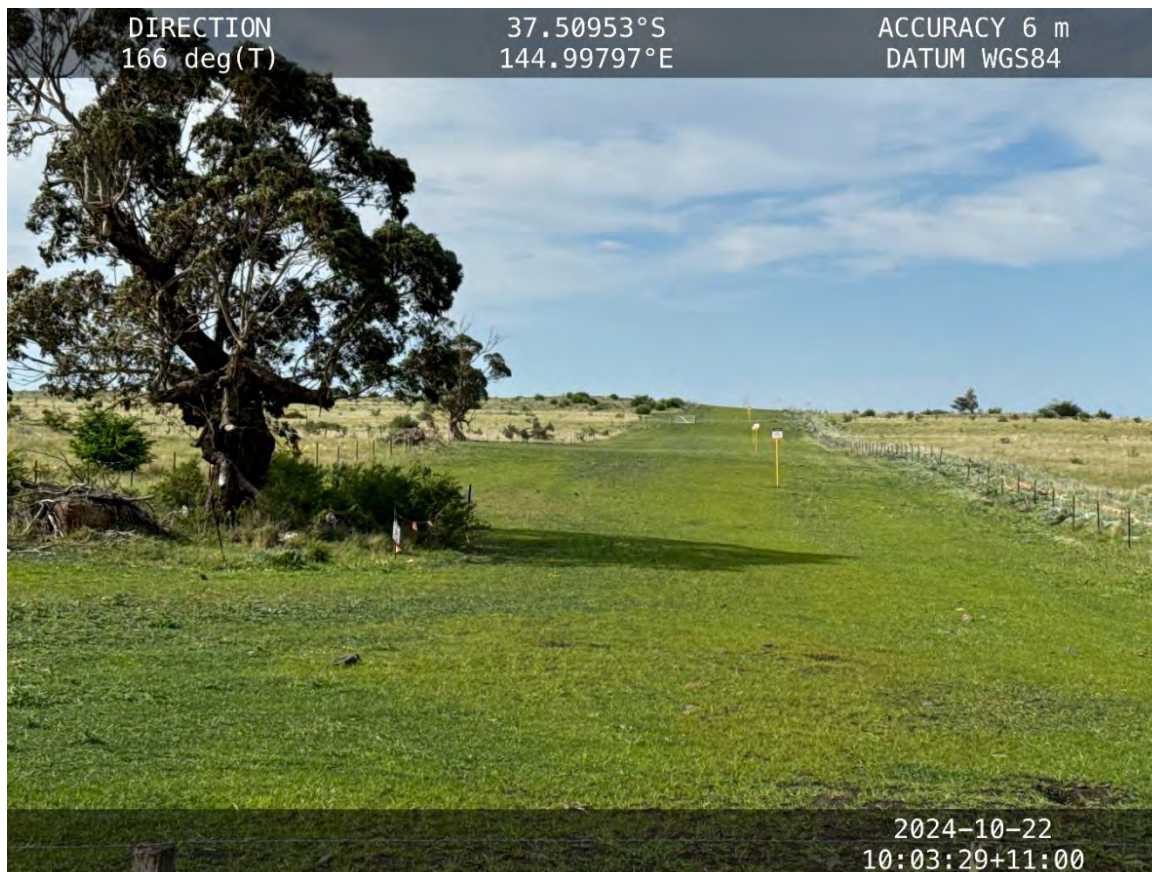
KP 42 Merri Creek – old tree with the appropriate signage.

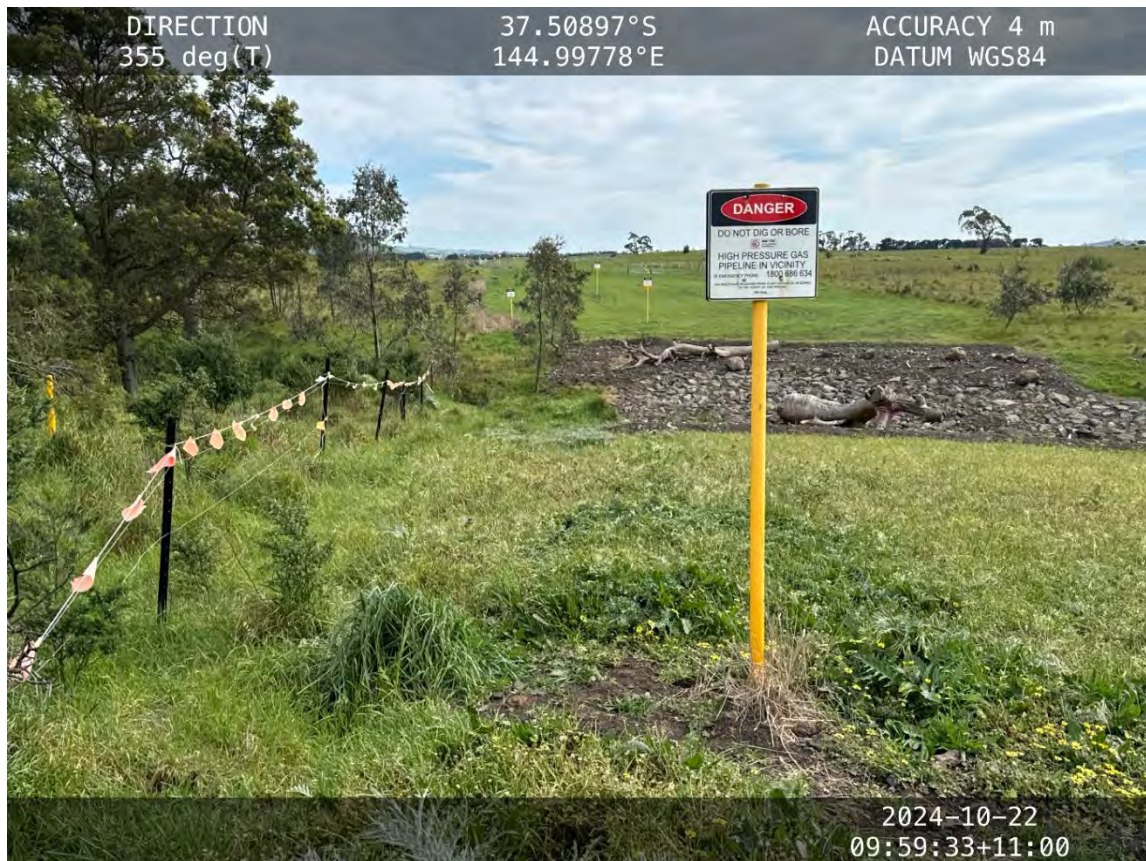
KP 42 Merri Creek – Pipeline marker and pipeline right-of-way border with vegetation growth.

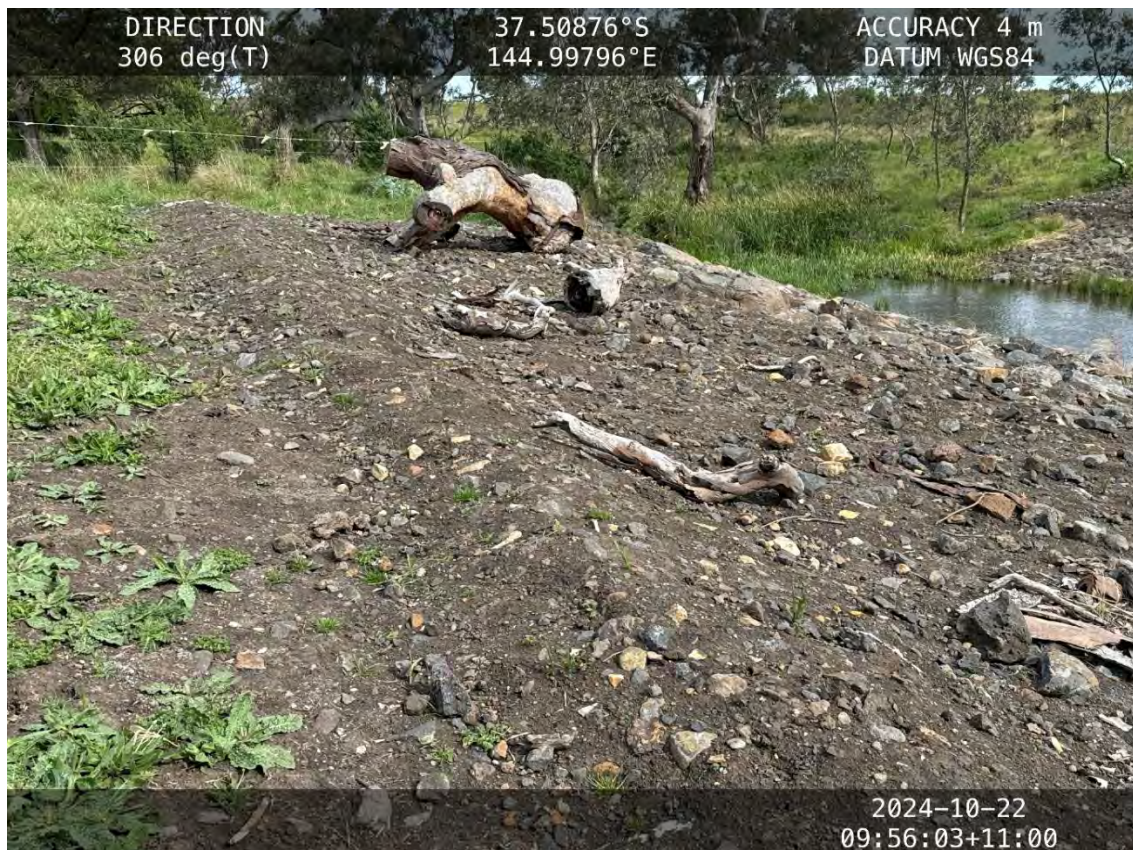
KP 42 Merri Creek – diversion berm along the bank with minimal vegetation growth and bank stabilisation evident.

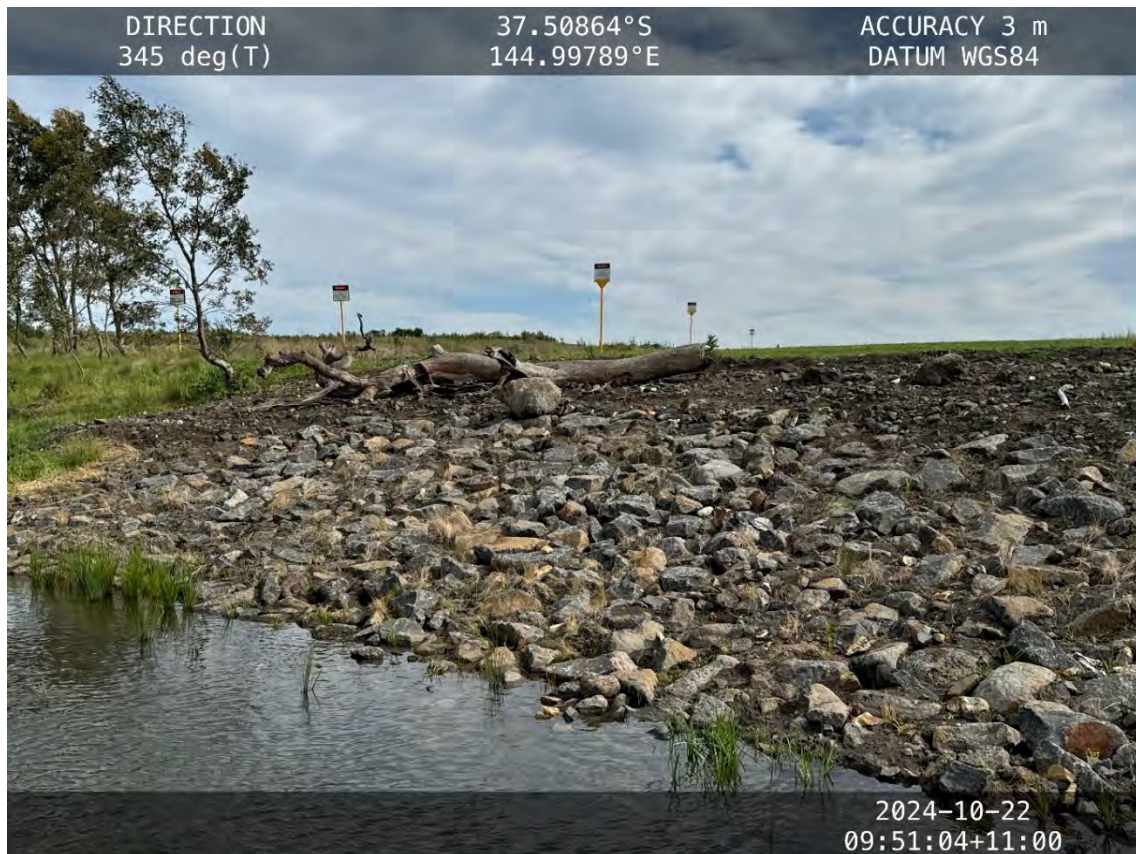
KP 42 Merri Creek – northern bank stabilisation with tubestock growth and tree placement

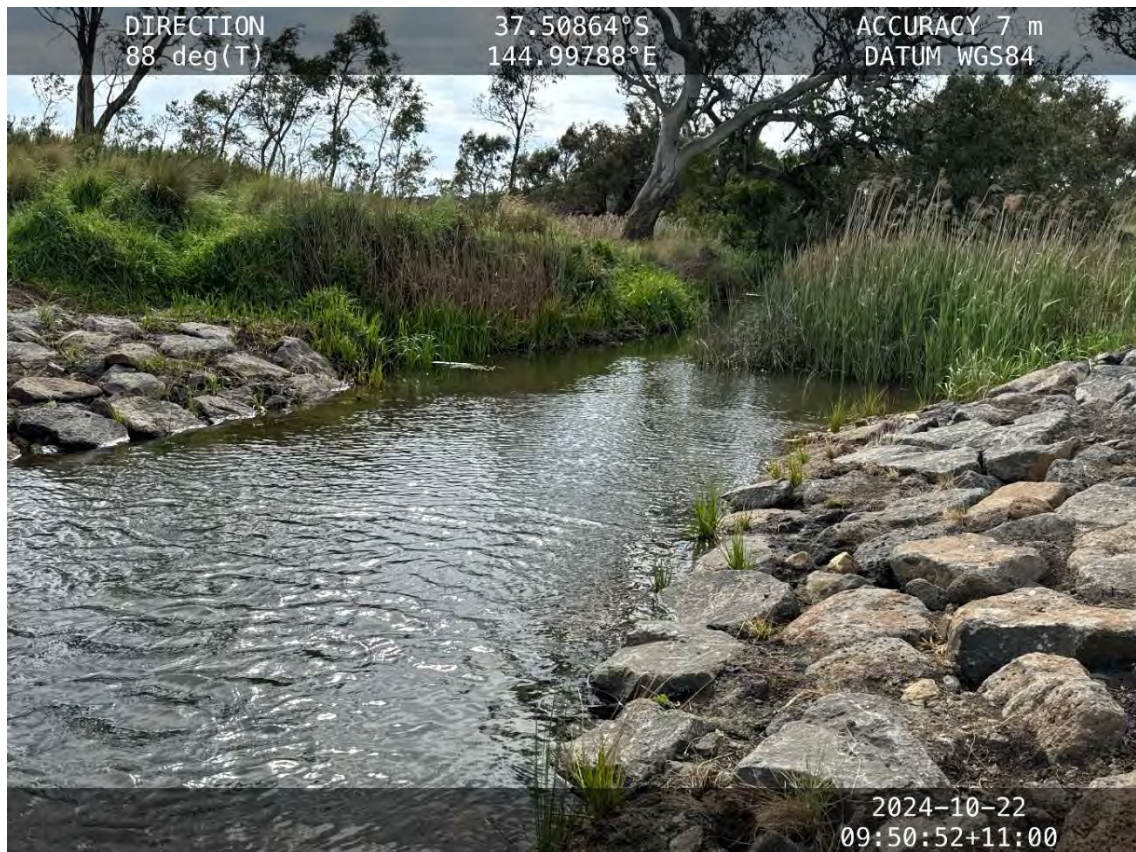
KP 42 Merri Creek – downstream view with water movement through the right-of-way and bank stabilisation.

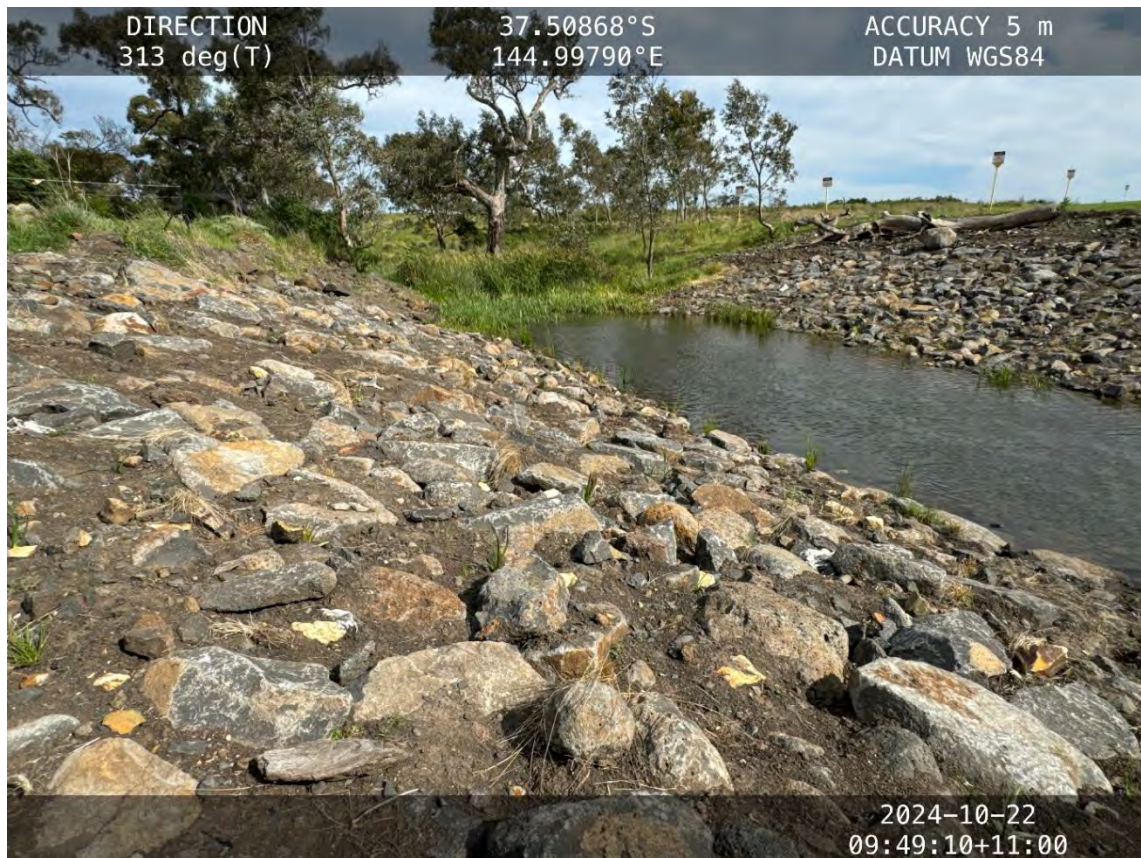
KP 42 Merri Creek – upstream view with bank stabilisation and minimal vegetation cover.

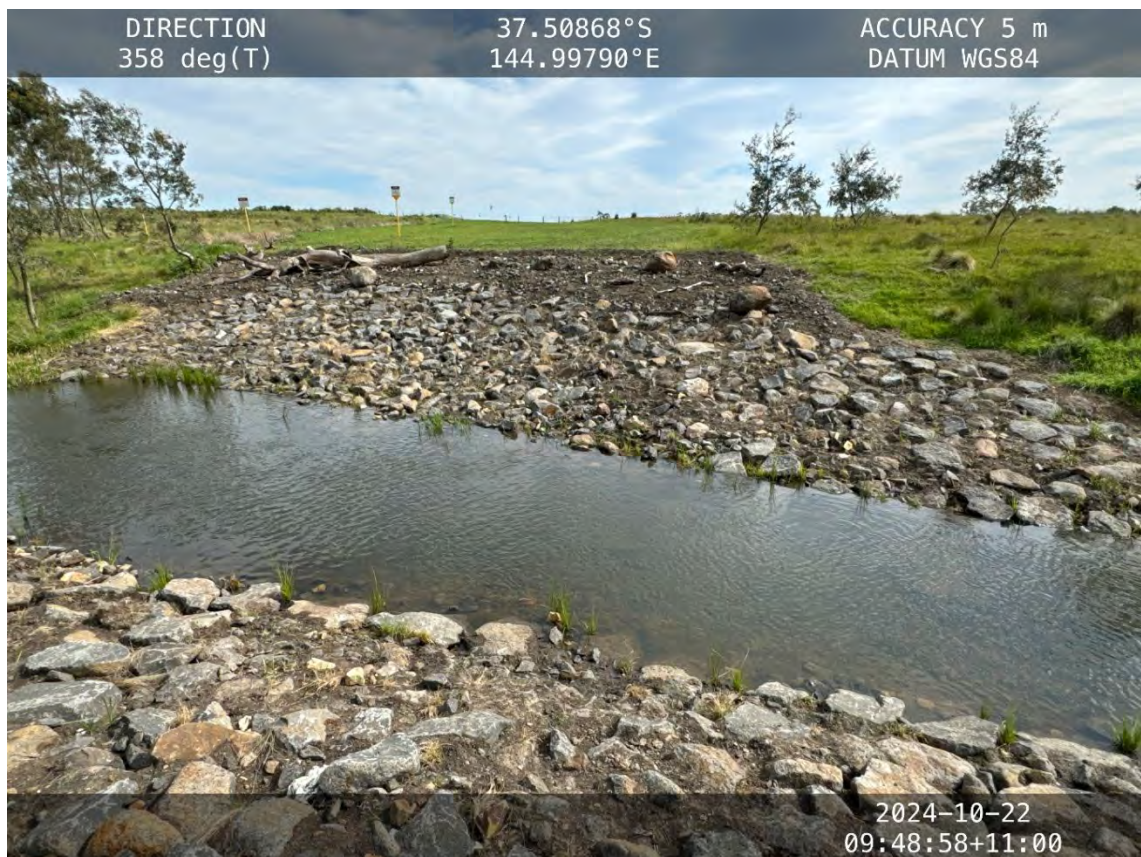
KP 42 Merri Creek – pipeline right-of-way with bank stabilisation, tubestock growth and exposed rock.

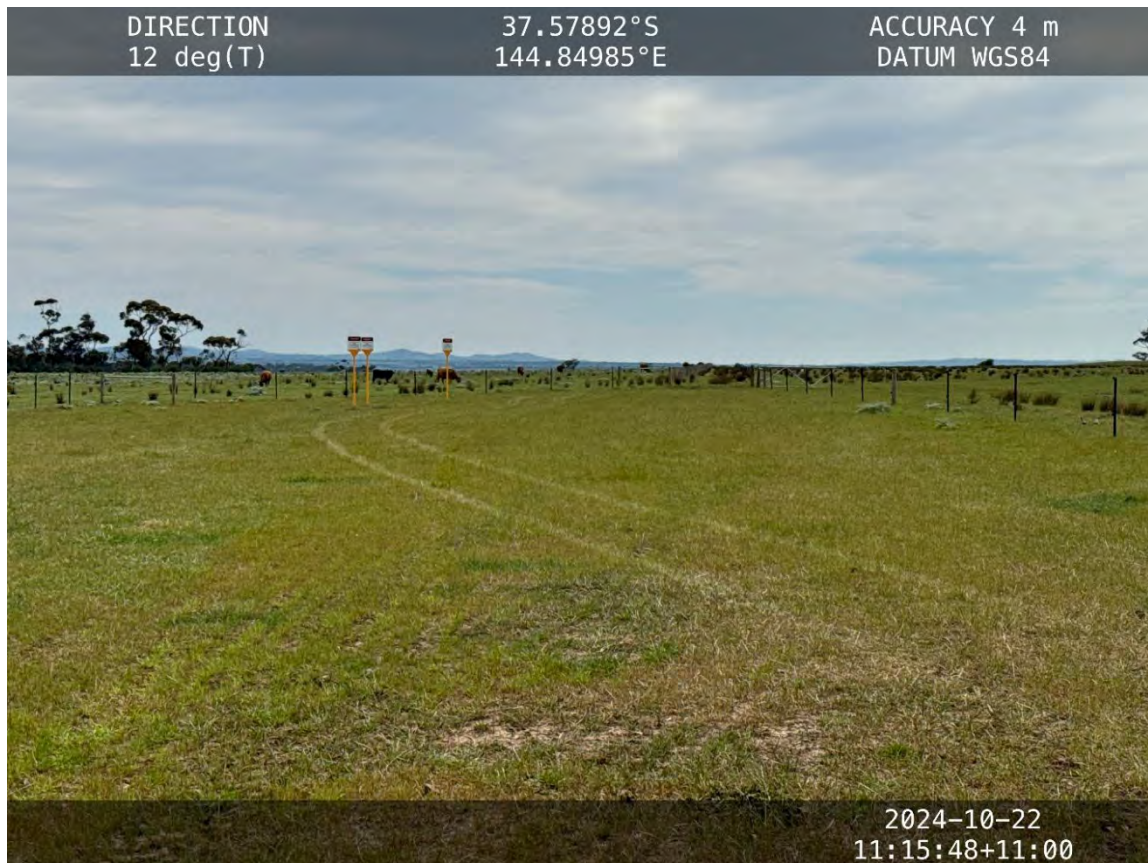
KP 22.6 to 22.8 Property 1 PS733045 – rehabilitated pipeline right-of-way and pipeline markers.

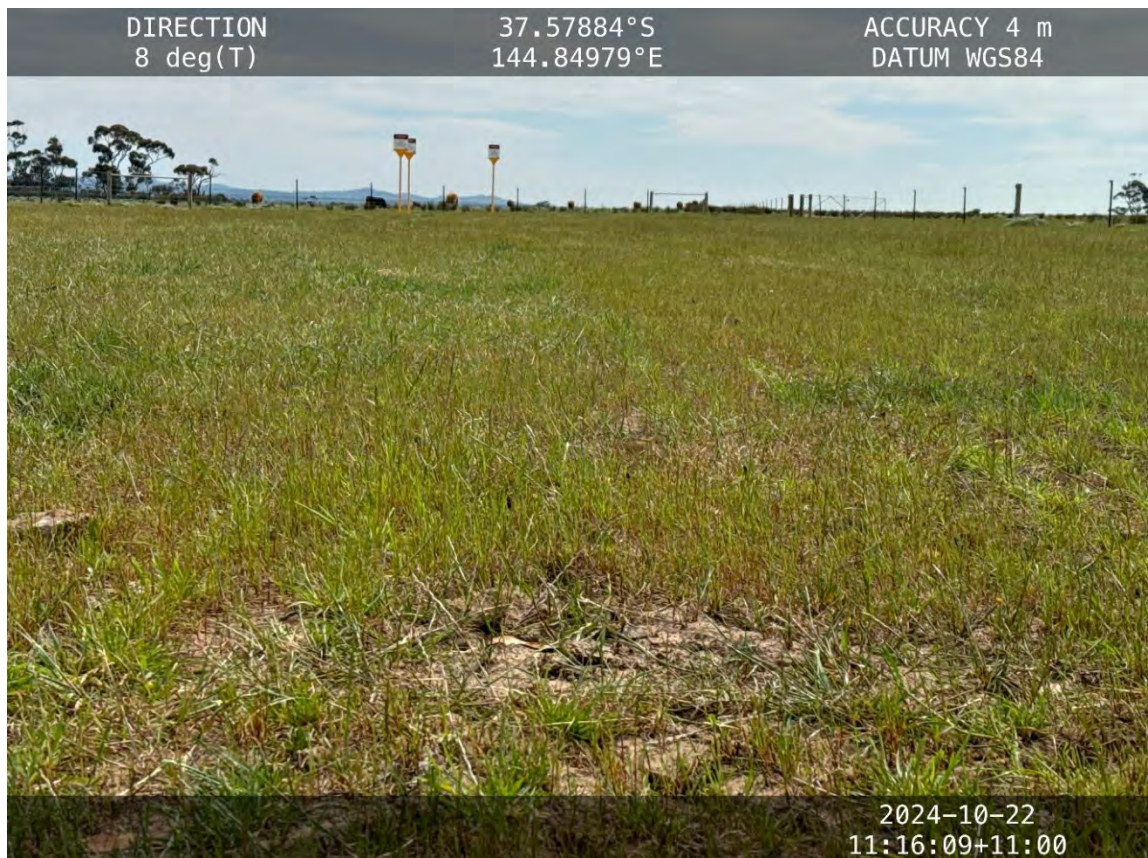
KP 22.6 to 22.8 Property 1 PS733045 – vegetation cover and installed fence and gate.

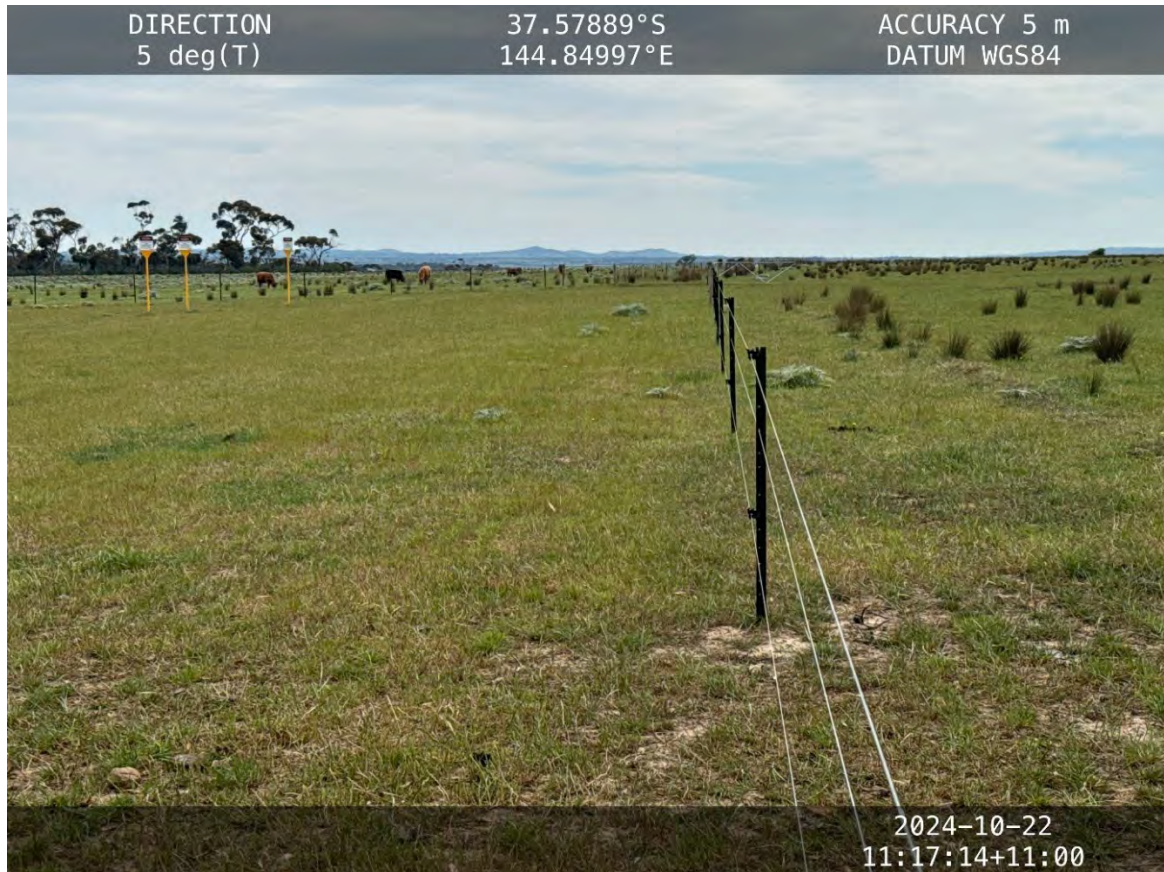
KP 22.6 to 22.8 Property 1 PS733045 – installed fence and vegetation matching the surrounding area.

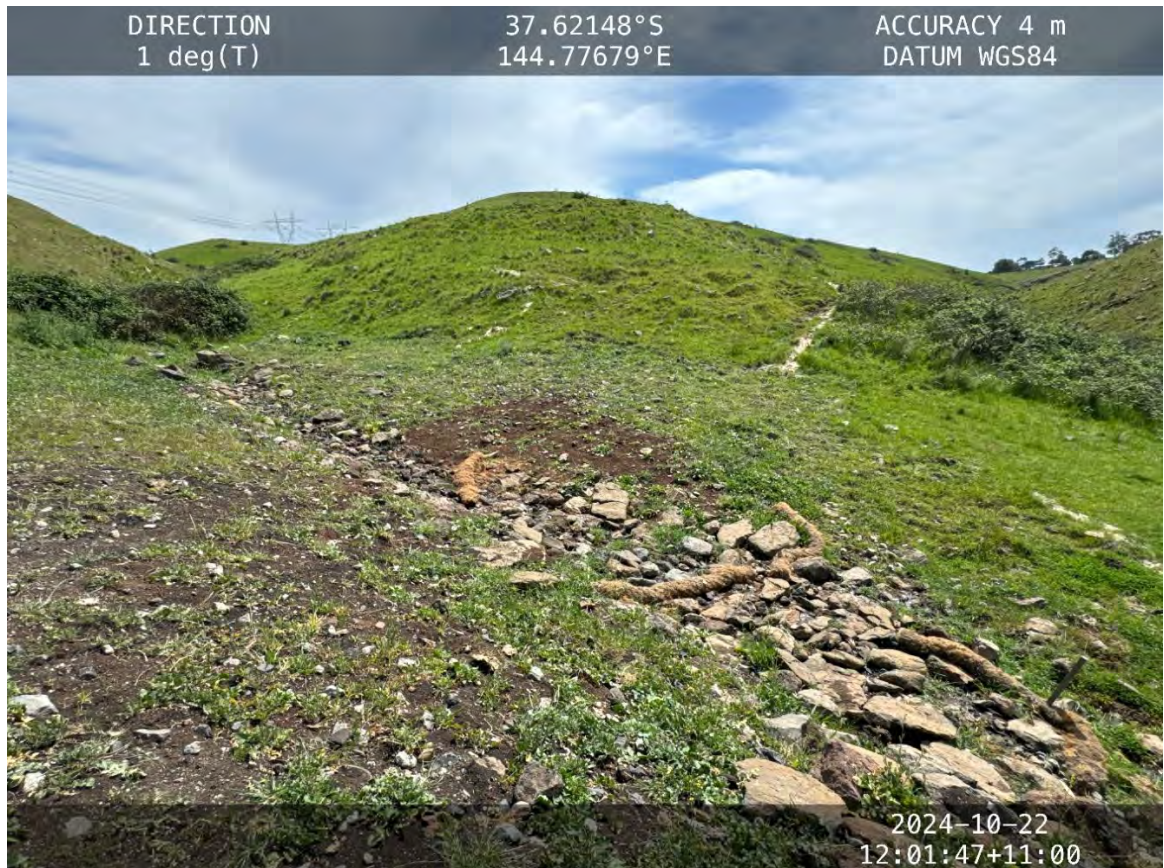
KP 13.8-14 Jackson Creek – degrading coir logs to control erosion.

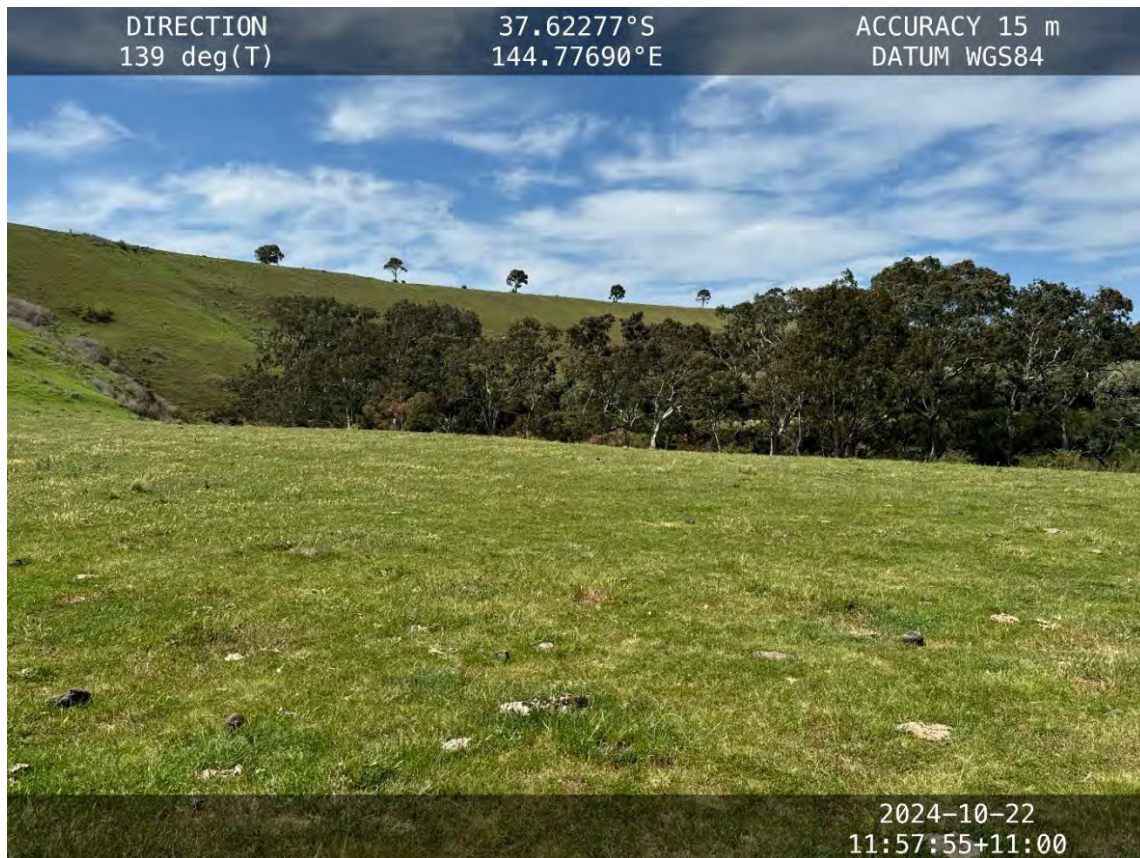
KP 13.8-14 Jackson Creek – vegetated area with rock placement.
