# **Third-Party Environmental Compliance Audit, WORM Pipeline – Reinstatement audit**

**Rev 0**

**8 September 2025**

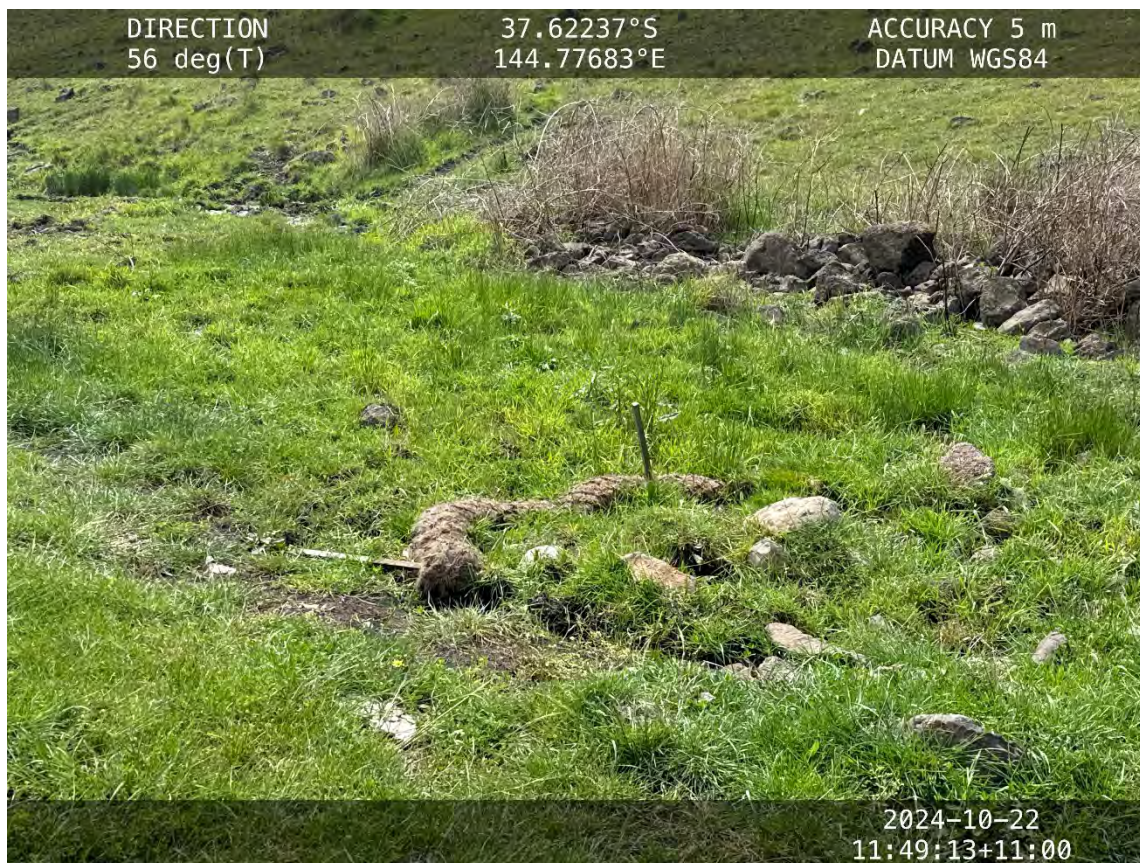
KP 13.8-14 Jackson Creek – degrading coir logs used to control erosion at the emergency work area.

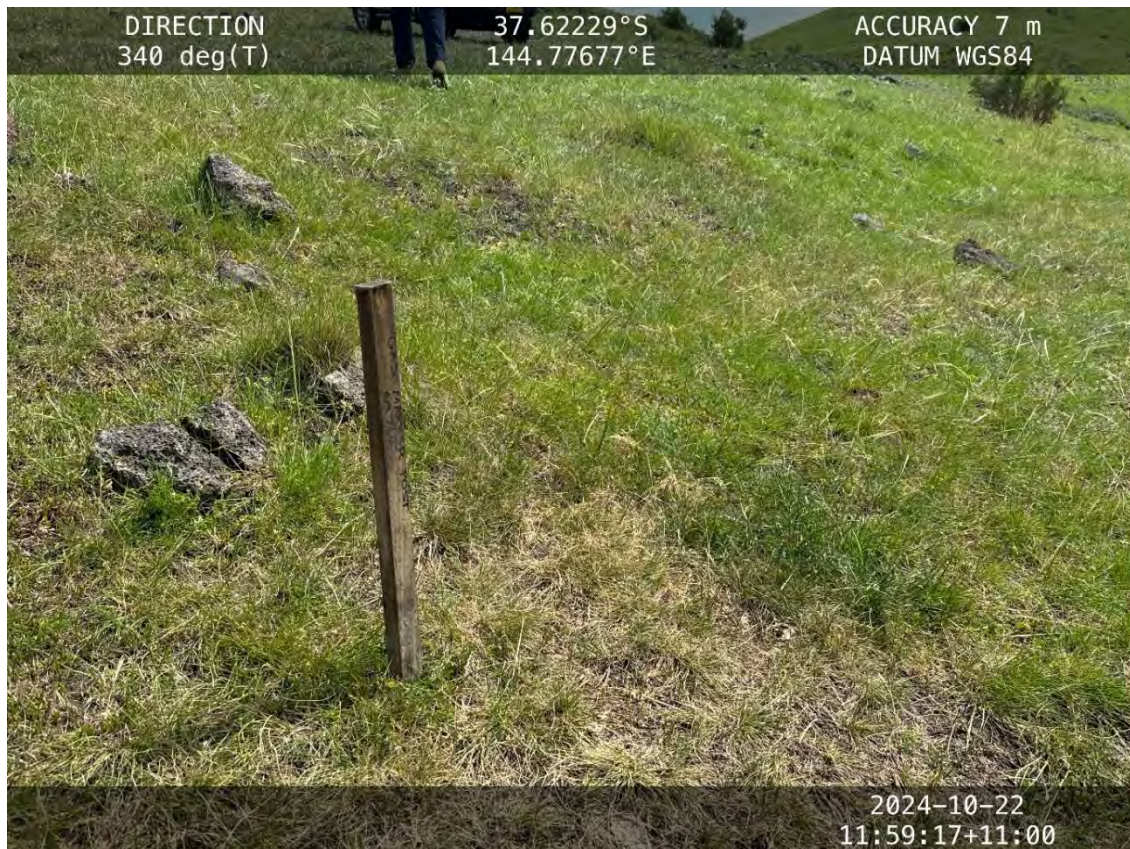
KP 13.8-14 Jackson Creek – wooden stakes remain in place.

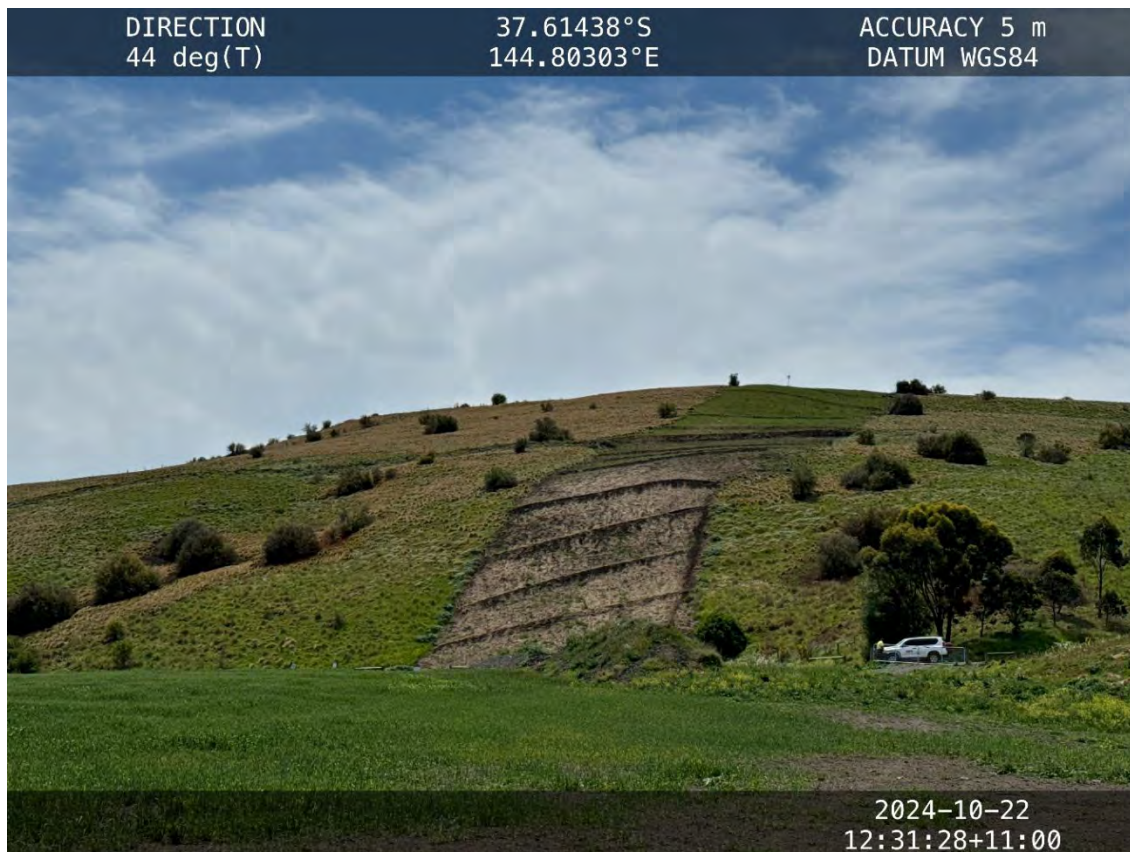
KP 16.8 Deep Creek – revegetated pasture with view of slope rehabilitation.

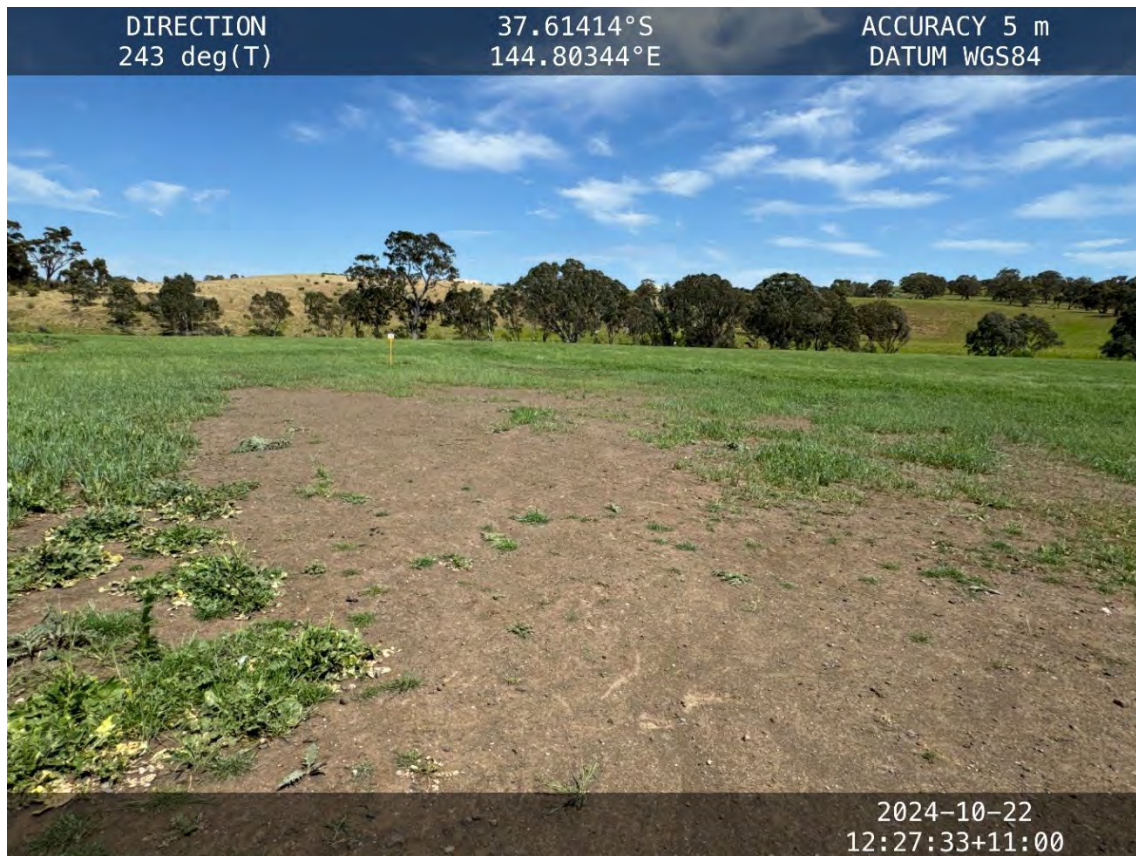
KP 16.8 Deep Creek – patch of bare soil at former HDD pad, tank and pit site surrounded by rehabilitated pasture.

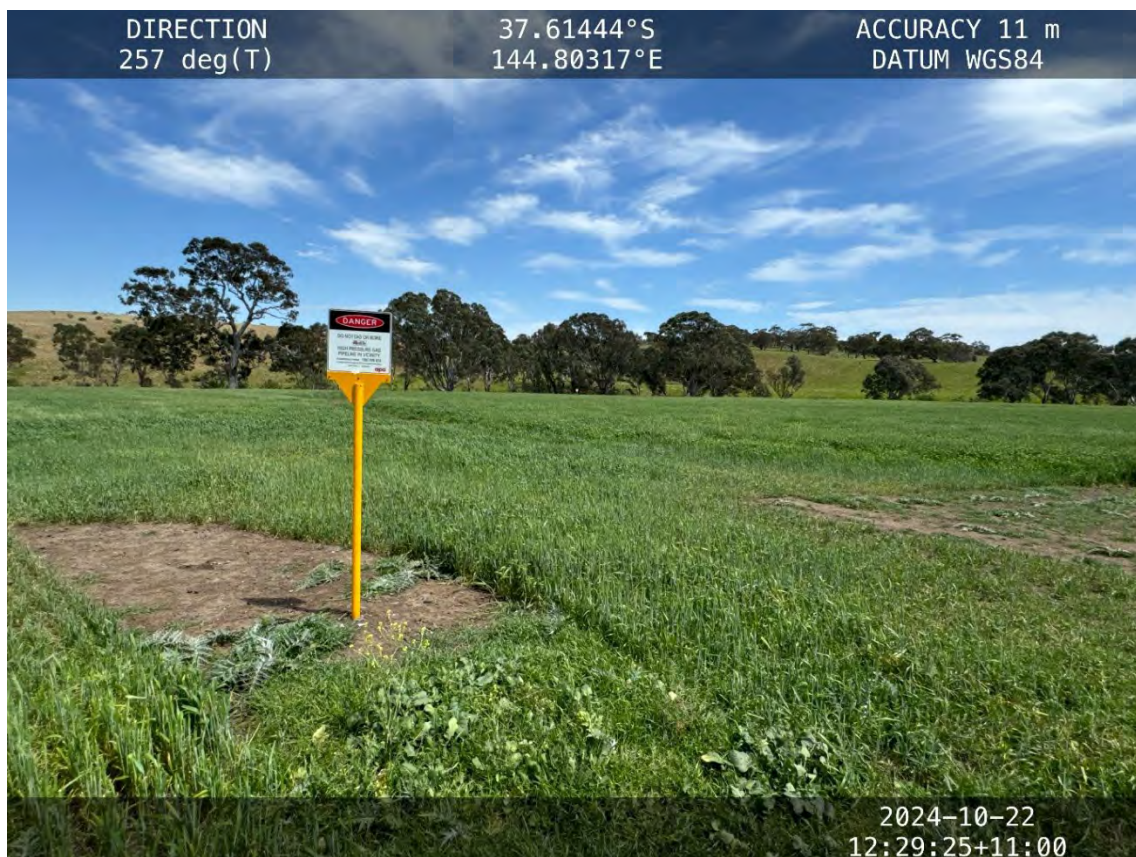
KP 16.8 Deep Creek – vegetated crop growth area with small soil patch surrounding pipeline marker.

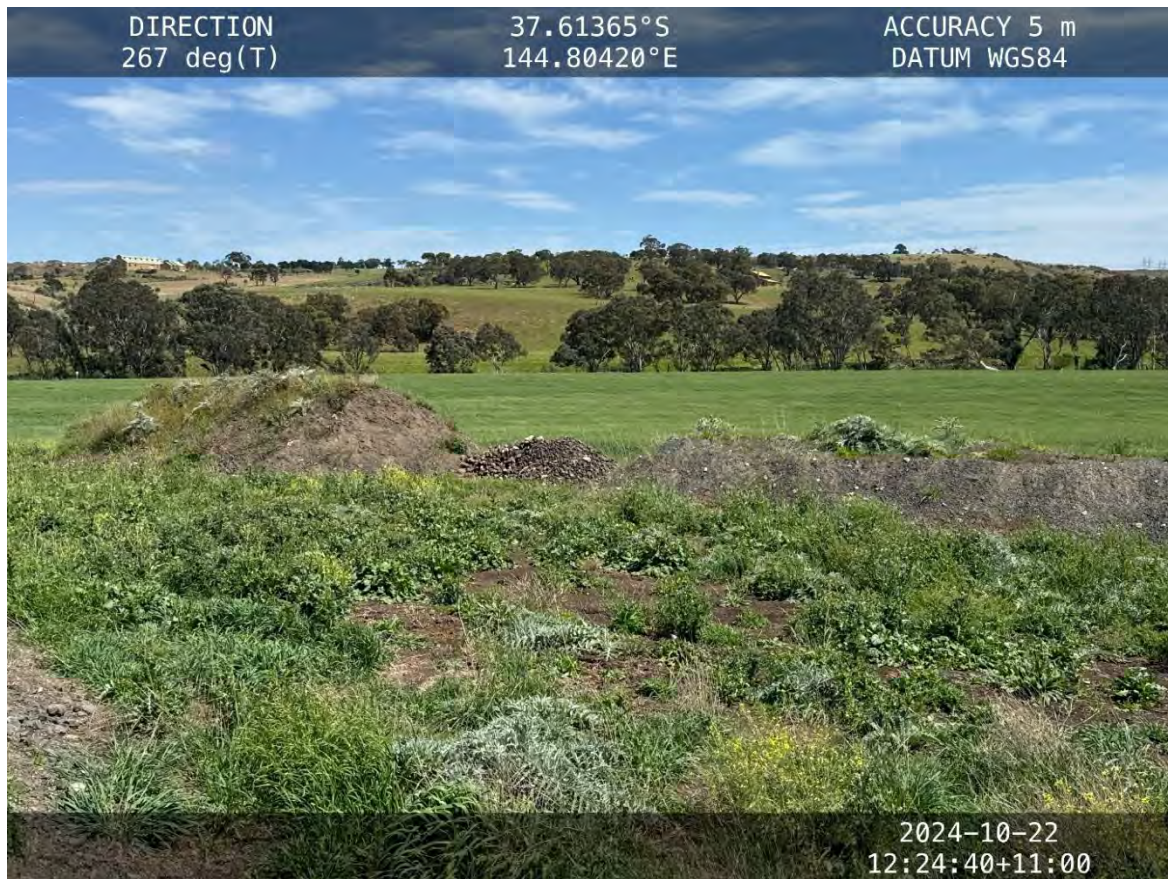
KP 16.8 Deep Creek – soil mounds retained on the property at the landowner's request.

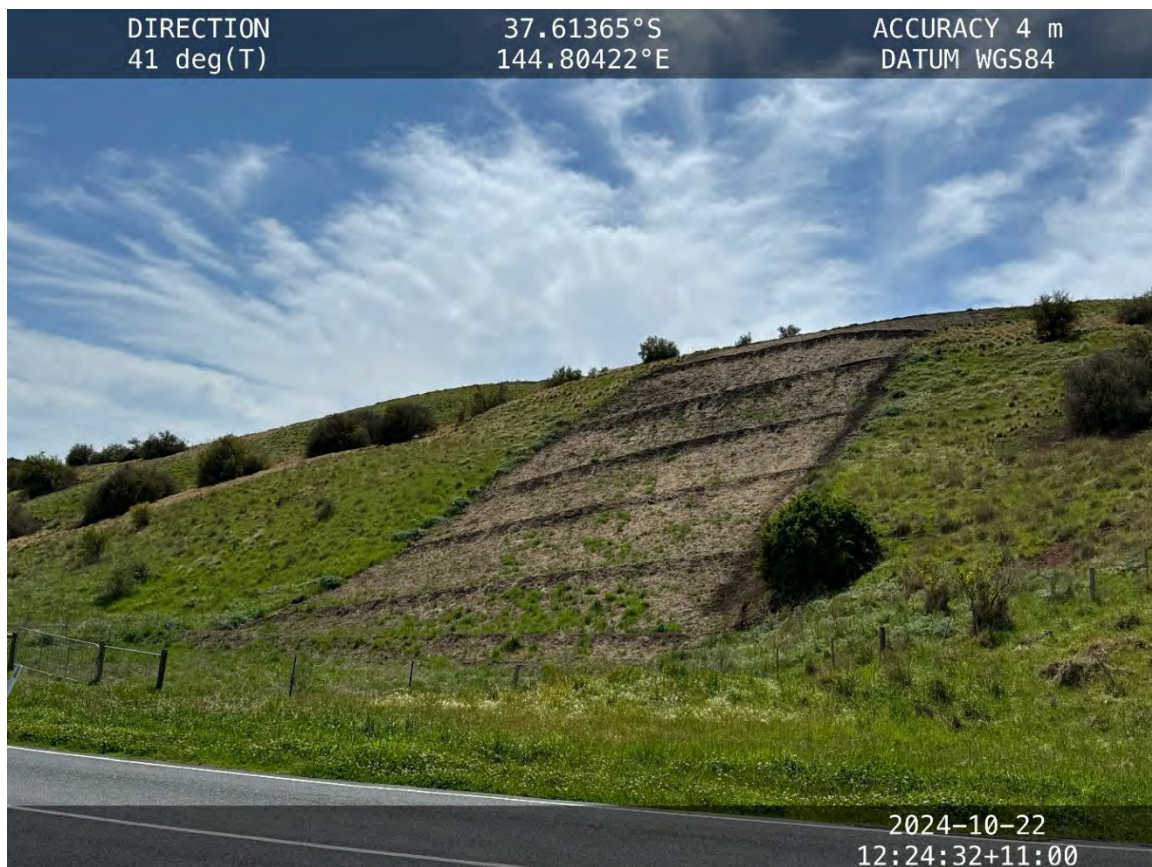
KP 16.8 Deep Creek – berms and vegetation growth upslope.
